## THE CHEVRON SIGN

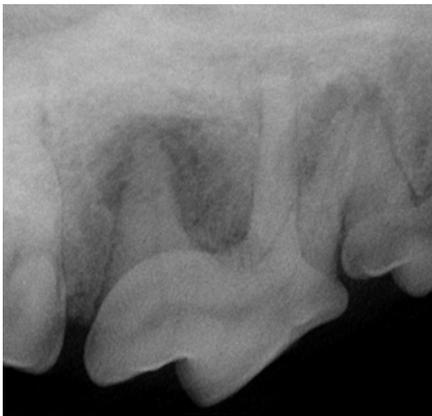
In the last issue of The CUSP, I discussed radiographic and optical indications of endodontic disease in [www.toothvet.ca/PDFfiles/endo\\_dx.pdf](http://www.toothvet.ca/PDFfiles/endo_dx.pdf). One of the important radiographic signs of endodontic disease is the periapical lucency. In the radiograph below of the right maxillary fourth premolar tooth in a dog we see very obvious periapical (around the root tips) radiolucencies (areas of decreased density). These dark halos around the root tips are definite signs of inflammation which almost certainly stems from endodontic disease (septic pulp necrosis). When you see lesions as obvious as this, you know this is a chronic problem. There has to be a lot of bone loss before there is enough contrast for it to show up radiographically. Therefore, it is possible to have a tooth with endodontic disease and inflammation around the root tips that still looks perfectly normal radiographically because there has not yet been enough bone loss to show up on the image.

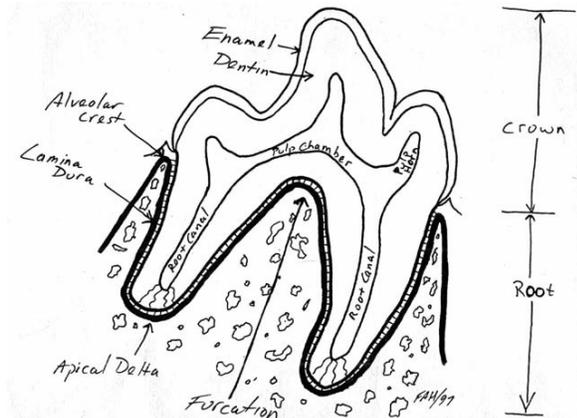
In my drawing above, you can see the periodontal ligament space is a consistent width around the entirety of both roots. Radiographically it shows up as a thin dark line between root and bone. The lamina dura is a thin layer of dense cortical bone that lines the socket and shows up radiographically as a thin white (dense) line.

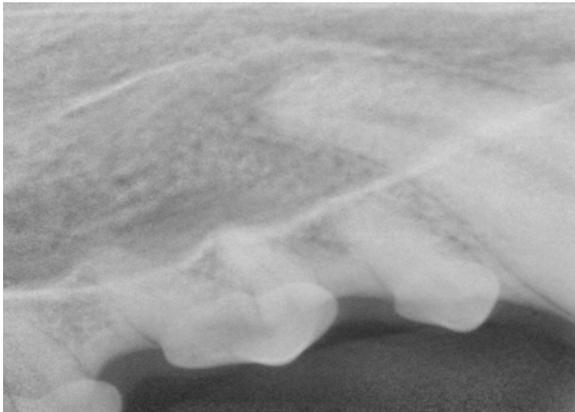
The next radiograph is of the apex of the right upper canine tooth in a dog. There seems to be an area of decreased bone density at the apex. The tooth was clinically normal and there was no reason to suspect endodontic disease. The left canine tooth looked the same. Therefore, it was assessed as the chevron sign. A year later the same tooth looked basically unchanged except that the pulp chamber has gotten smaller (indicating continued normal pulp activity).

Image captured with an EVA-Vet direct digital sensor.

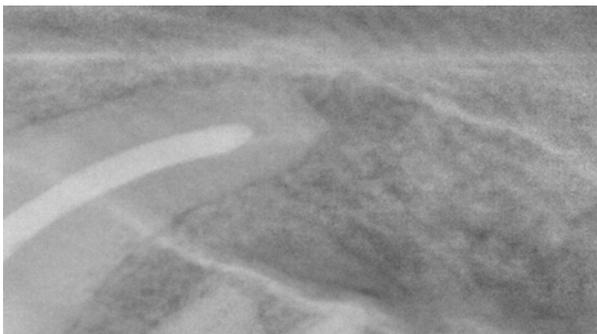
On the other hand, the lucency in the film below was assessed as a true periapical lesion indicative of periapical periodontitis of endodontic origin and so root canal treatment was performed.

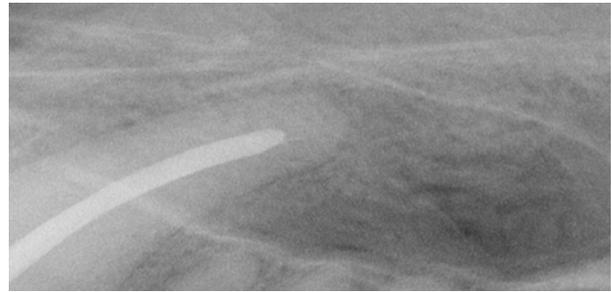
And a year later, the lesion had healed.

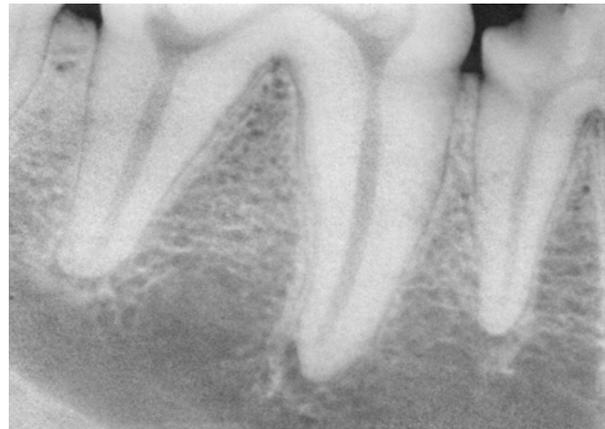
This next image is from the same dog and is of the right mandibular first molar.

Image captured with an EVA-Vet direct digital sensor.

There is a definite increase in the width of the periodontal ligament space at the apex of both roots. There was also some coronal damage as a potential portal of entry for bacteria into the pulp system and even a pulp stone in the chamber in the mesial cusp of the tooth, but as I assessed all the pieces of this particular puzzle, I decided that the radiographic findings in the apical region were within normal limits and I opted to do neither root canal treatment nor extraction. A year later, the tooth looked like this:

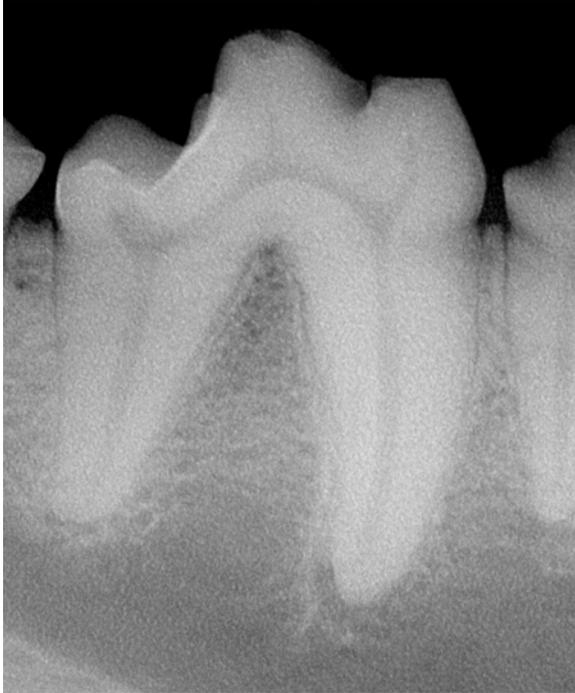
Image captured using the ScanX indirect digital system.

The periapical areas look unchanged, suggesting that my initial assessment was correct.

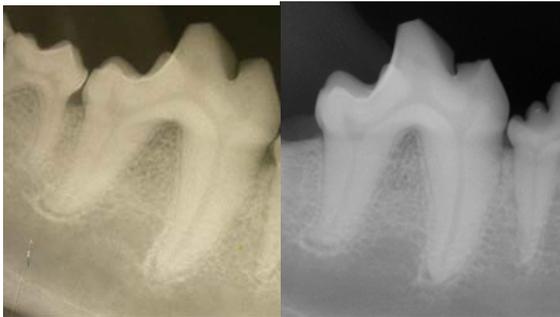
Here are two images of the right mandibular first molar in a different dog. The first is on analog film and the follow-up (a year later) is a ScanX image. Again, the chevron finding is consistent from one year to the next suggesting it is normal for this dog.

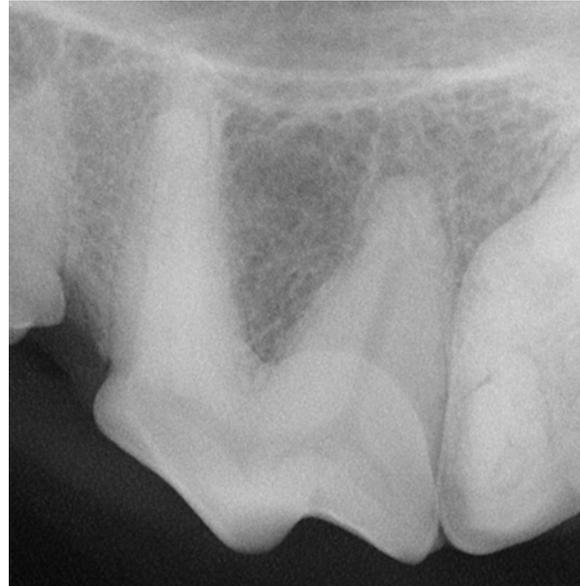
The other place I commonly see the chevron sign is at the distal root of the maxillary fourth premolar in large dogs as in this (ScanX) image.

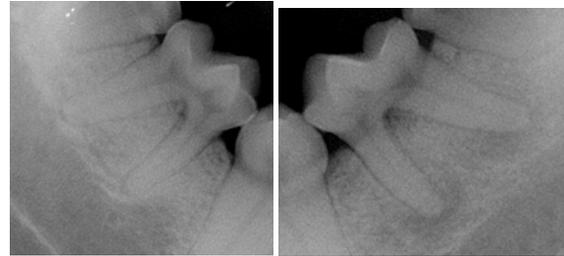
And as a reminder of what a true, endodontically induced chronic periapical periodontitis looks like radiographically, here is a normal right mandibular second molar in a large dog and its diseased left counterpart (both ScanX images):

Why did the left second molar develop endodontic disease? Probably occlusal trauma. A good message here is that there does not need to be any coronal damage for a tooth to have endodontic disease and considerable periapical bone demineralization. Therefore, intra-oral dental radiographs **need** to be a part of **every** dental patient's assessment. If you are not taking intra-oral dental radiographs, I can promise you that you are missing pathology and sending many of your patients home with undetected (and un treated) disease.

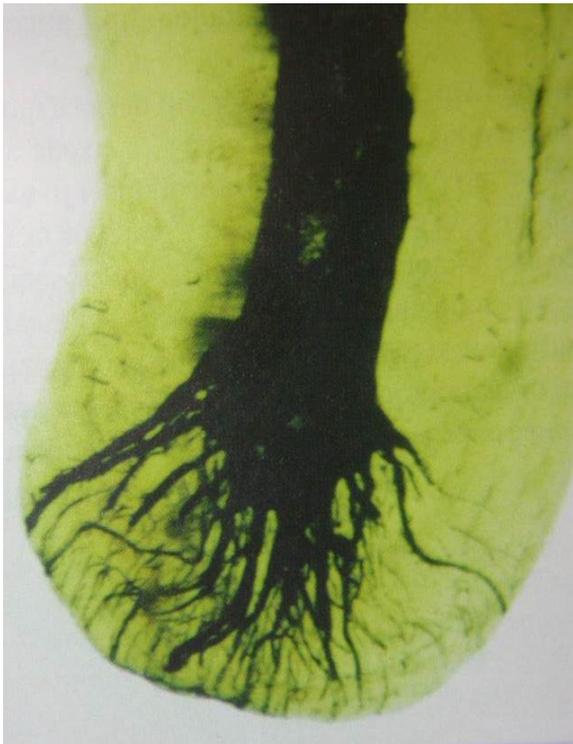
The periodontal ligament serves a number of functions, including shock-absorber for the tooth. The ligament allows some micro-movement of the tooth and allows occlusal forces to be dissipated into the surrounding bone, protecting both tooth and bone from fracture. At the tip of the root, we have the apical delta, comprising many tiny channels. Nerves, blood vessels and lymphatic vessels must leave the protection of bone, traverse the periodontal ligament space and pass through these tiny channels to enter the tooth to become part of the pulp organ.

If the periodontal ligament space is narrow around the apex of the root, when the dog bites down hard on something, the tooth may be intruded into the socket sufficiently to crush the vessels and nerves between the root tip and surrounding bone. A thicker periodontal ligament space around the apex will help protect these tiny structures from such trauma. Effectively, the wider periodontal ligament space at the apex of the big teeth in big dogs is just a thicker cushion to protect the communication between the pulp and the rest of the body.
