## RADIOGRAPHIC INTERPRETATION: A CASE STUDY.

This is a one-year-old Boston terrier with a history of facial trauma roughly 36 hours prior to presentation to the referring clinic. The attached radiographs of the left mid-mandible were obtained under general anesthesia.

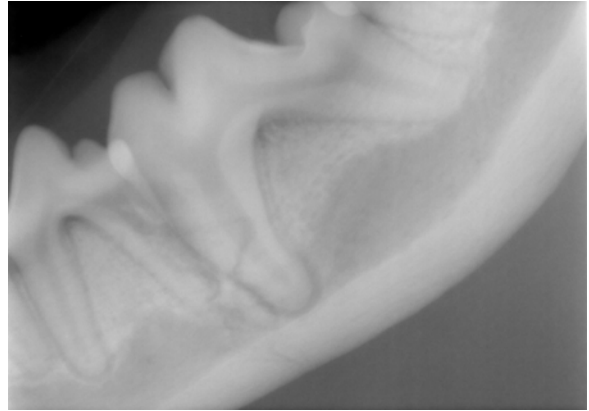
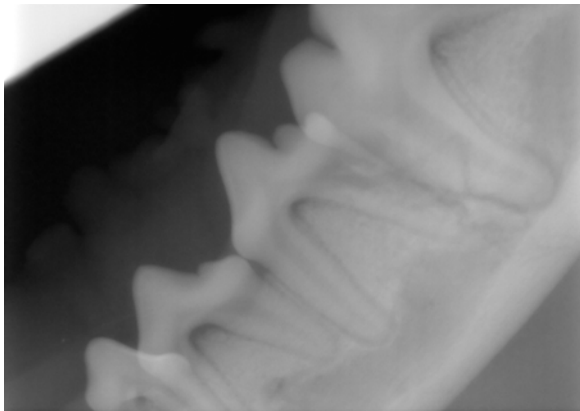
So what are we seeing here? There appear to be fracture lines but what is it that is broken? This highlights the limitation of viewing a two-dimensional representation of a three dimensional object. There is a lucent line that seems to involve the distal root of the 4<sup>th</sup> premolar (308) and the 1<sup>st</sup> molar (309). Are these roots fractured?

Also, the root fractures tend to be right through the root from one side to the other. In the rads of the Boston terrier, there appears to be a triangular section broken out of the mesial aspect of the mesial root of the 1<sup>st</sup> molar deep within the confines of the alveolus. In evaluating these images we need to ask, how could a root fracture of that shape happen in that location? It seems exceedingly unlikely that it could happen. So if the root is not fractured, what is? The only other dense tissue there is bone.

In the marked image below, I have tried to highlight the various fracture lines in the mandible. One line is on the buccal side of the teeth and the other is on the lingual side. What we have here is a mandibular fracture running dorso-ventral in the region between the distal root of the 4<sup>th</sup> premolar and the mesial root of the 1<sup>st</sup> molar.

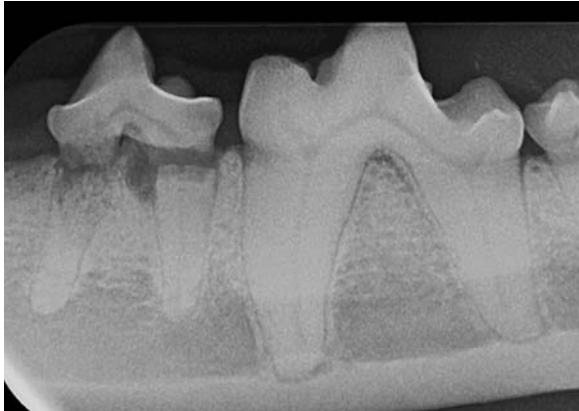
Root fracture certainly does happen, but when it does it is usually at the fulcrum point at the top of the bony socket (alveolus) as in this image of an old root fracture of the lower left 4<sup>th</sup> premolar in a miniature poodle.

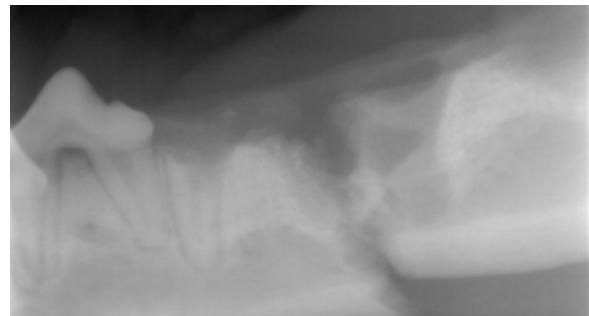
Making the distinction between mandibular fracture and root fracture is essential because mis-interpretation of the situation will result in serious problems – and that is what happened. The primary care clinicians assessed that the fractures were of the distal root of the 4<sup>th</sup> premolar and the mesial root of the 1<sup>st</sup> molar and so decided that these two teeth needed to be extracted. They started that surgery and then realized they were on the wrong path and took this intra-operative image.

At this stage they have removed the 1<sup>st</sup> molar and the distal root of the 4<sup>th</sup> premolar. They were having trouble removing the mesial root of the 4<sup>th</sup> premolar and noted the mobility and displacement across the mandibular fracture and so aborted the procedure and contacted us. We arranged to see the dog the next day.

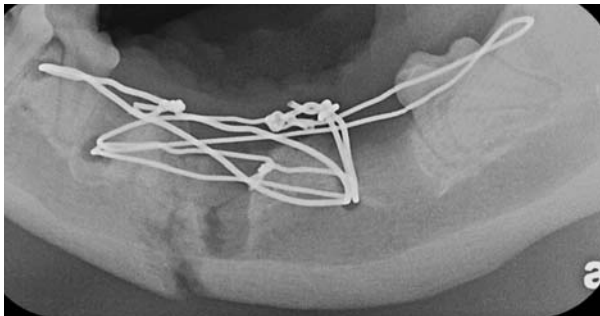
At this point, we have a displaced and mobile mandibular fracture, enough distraction to cause concern regarding the health/integrity of the neurovascular bundle and insufficient dental structure distal to the fracture line to hold an intra-oral splint. While I really dislike the use of orthopedic wire for managing facial fractures

Treatment involved removal of the rest of the 4<sup>th</sup> premolar and then open reduction of the fracture using orthopedic wire through various pilot holes and bridging the fracture at various angles. Following placement of the wires, the buccal and labial flaps were sutured over the wires and bone in order to isolate the wires from communication with the oral cavity. To do this, I also actually sutured the flap over the top of the 2<sup>nd</sup> molar, figuring I could re-expose or extract this tooth at follow-up.

With mandibular fractures, the dorsal border of the mandible is known as the tension side and the ventral border is the compression side. This is because both gravity and the resistance to mastication push the chin ventrally (down) while the muscles of mastication pull the distal portion of the mandible dorsally (up). Therefore it is important to counter-act the tension across the dorsal border of the fracture and this is what these wires were doing. The small gap ventrally is not a great concern because the forces of compression would be inclined to close this gap as the wires 'stretch' or loosen post-operatively.

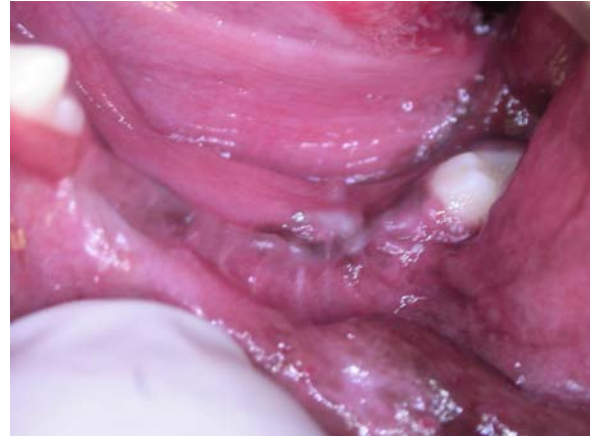
At follow-up, the soft tissues looked like this:

Some of the knots in the wire are visible under the mucosa near the distal part of the site but the mucosa is intact and healthy. What really surprised me was that the 2<sup>nd</sup> molar had re-erupted and the gingiva around it looked perfectly happy and healthy. Remember, I had buried this tooth under the flaps. Isn't nature amazing!

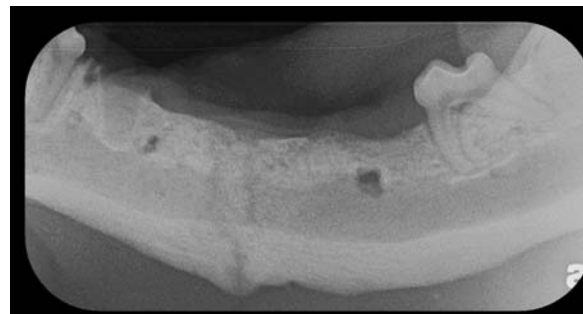
I was very happy with this so I made an incision along the dorsal margin of the site to reflect the soft tissue and removed all the wires and the 3<sup>rd</sup> premolar. Here is the final post-op rad:

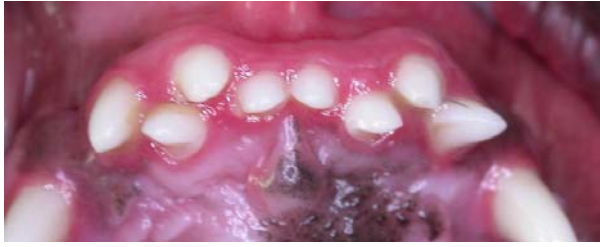
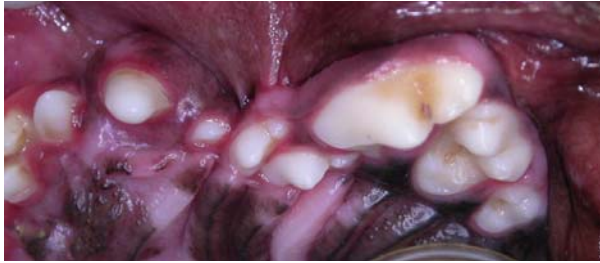
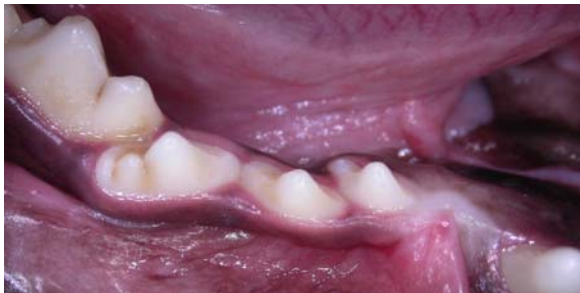
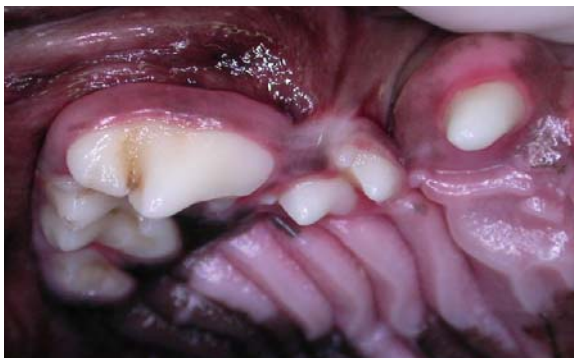
Then I dealt with other 'micro-dog' issues (see [microdogs.pdf](#)) such as extracting some supernumerary maxillary incisors and extracting several other teeth to alleviate the serious

crowding and rotations (see the pre-op photos) that would have pre-disposed to uncontrollable periodontal disease.
