RADIOGRAPHIC INTERPRETATION: A CASE STUDY.

This is a one-year-old Boston terrier with a history of facial trauma roughly 36 hours prior to presentation to the referring clinic. The attached radiographs of the left mid-mandible were obtained under general anesthesia.

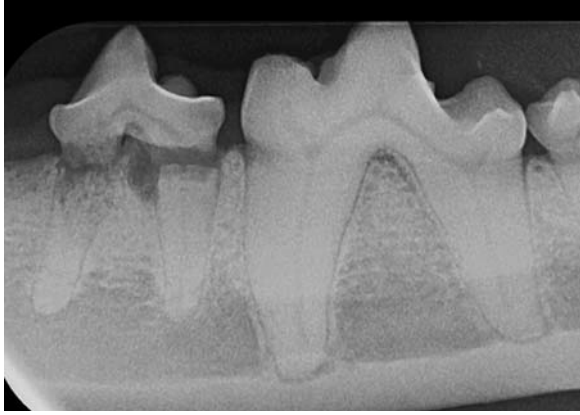
Root fracture certainly does happen, but when it does it is usually at the fulcrum point at the top of the bony socket (alveolus) as in this image of an old root fracture of the lower left 4th premolar in a miniature poodle.

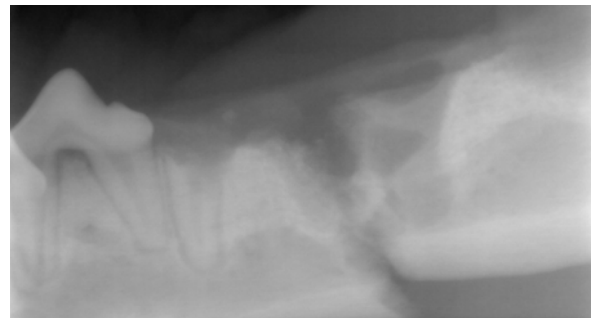
Making the distinction between mandibular fracture and root fracture is essential because mis-interpretation of the situation will result in serious problems – and that is what happened. The primary care clinicians assessed that the fractures were of the distal root of the 4th premolar and the mesial root of the 1st molar and so decided that these two teeth needed to be extracted. They started that surgery and then realized they were on the wrong path and took this intra-operative image.

At this stage they have removed the 1st molar and the distal root of the 4th premolar. They were having trouble removing the mesial root of the 4th premolar and noted the mobility and displacement across the mandibular fracture and so aborted the procedure and contacted us. We arranged to see the dog the next day.

At this point, we have a displaced and mobile mandibular fracture, enough distraction to cause concern regarding the health/integrity of the neurovascular bundle and insufficient dental structure distal to the fracture line to hold an intra-oral splint. While I really dislike the use of orthopedic wire for managing facial fractures

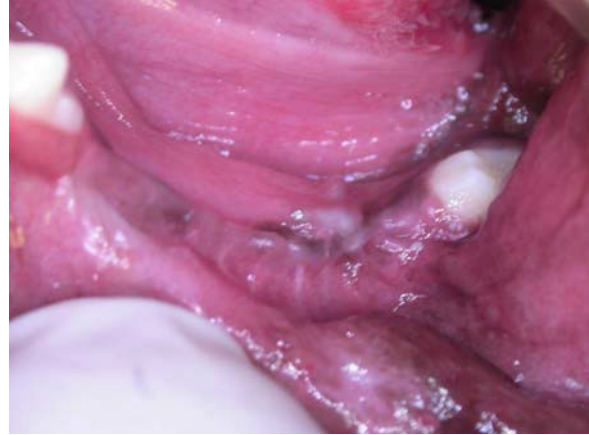
At follow-up, the soft tissues looked like this:

Some of the knots in the wire are visible under the mucosa near the distal part of the site but the mucosa is intact and healthy. What really surprised me was that the 2nd molar had re-erupted and the gingiva around it looked perfectly happy and healthy. Remember, I had buried this tooth under the flaps. Isn't nature amazing!

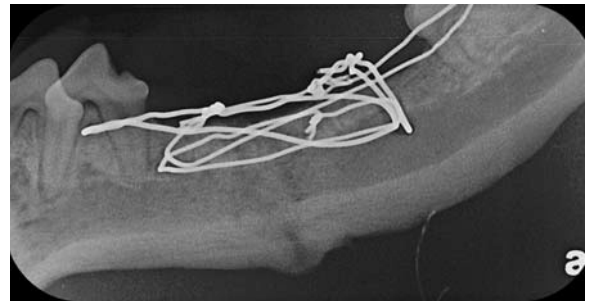
Radiographically, we had this:

I was very happy with this so I made an incision along the dorsal margin of the site to reflect the soft tissue and removed all the wires and the 3rd premolar. Here is the final post-op rad:

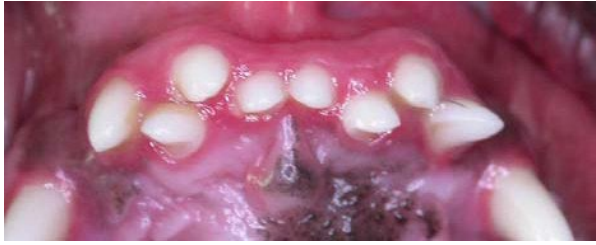
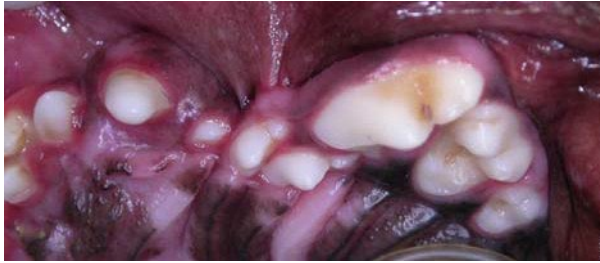
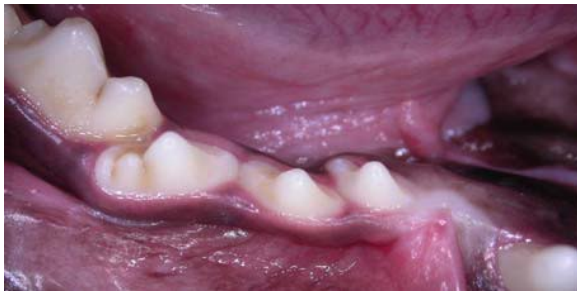
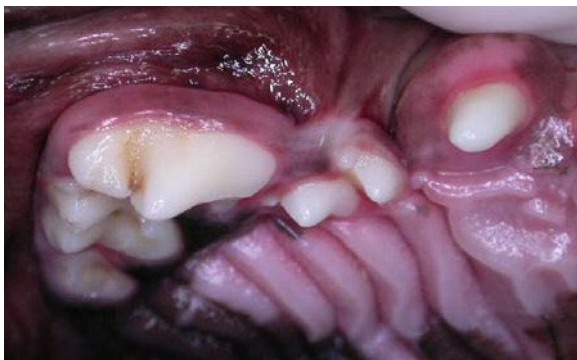
Then I dealt with other 'micro-dog' issues (see [microdogs.pdf](#)) such as extracting some supernumerary maxillary incisors and extracting several other teeth to alleviate the serious

crowding and rotations (see the pre-op photos) that would have pre-disposed to uncontrollable periodontal disease.

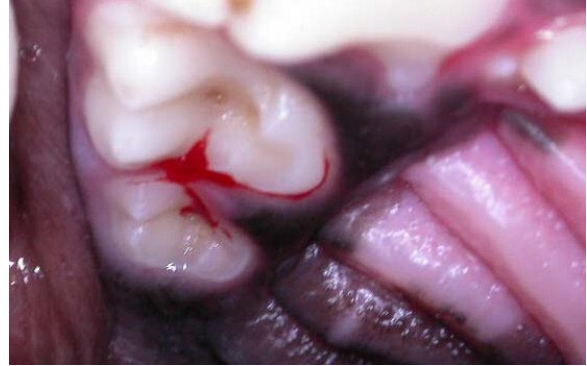
I also removed the right maxillary 2nd molar because the discolouration of the crown indicated that the pulp in this tooth was dead ([endo_dx.pdf](#)).
