RADIOGRAPHIC INTERPRETATION: A CASE STUDY.

This is a one-year-old Boston terrier with a history of facial trauma roughly 36 hours prior to presentation to the referring clinic. The attached radiographs of the left mid-mandible were obtained under general anesthesia.

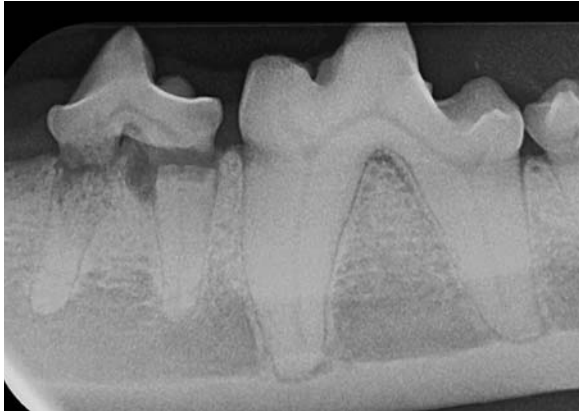
Root fracture certainly does happen, but when it does it is usually at the fulcrum point at the top of the bony socket (alveolus) as in this image of an old root fracture of the lower left 4th premolar in a miniature poodle.

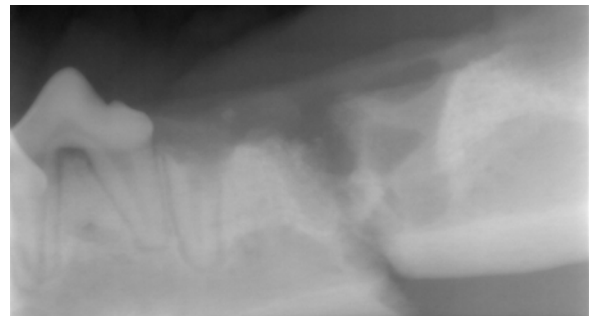
At this stage they have removed the 1st molar and the distal root of the 4th premolar. They were having trouble removing the mesial root of the 4th premolar and noted the mobility and displacement across the mandibular fracture and so aborted the procedure and contacted us. We arranged to see the dog the next day.

At this point, we have a displaced and mobile mandibular fracture, enough distraction to cause concern regarding the health/integrity of the neurovascular bundle and insufficient dental structure distal to the fracture line to hold an intra-oral splint. While I really dislike the use of orthopedic wire for managing facial fractures

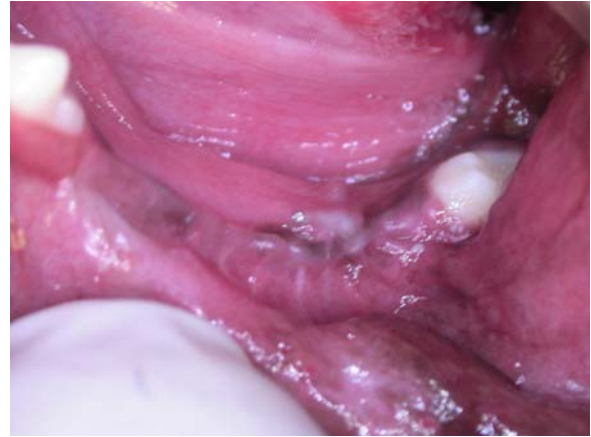
At follow-up, the soft tissues looked like this:

Some of the knots in the wire are visible under the mucosa near the distal part of the site but the mucosa is intact and healthy. What really surprised me was that the 2nd molar had re-erupted and the gingiva around it looked perfectly happy and healthy. Remember, I had buried this tooth under the flaps. Isn't nature amazing!

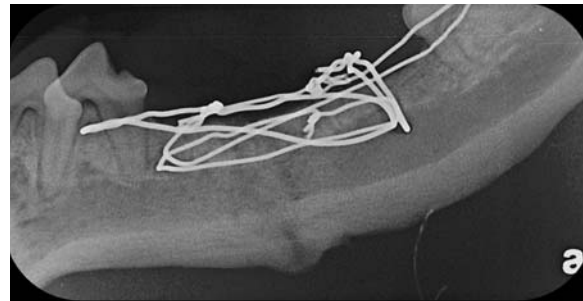
Radiographically, we had this:

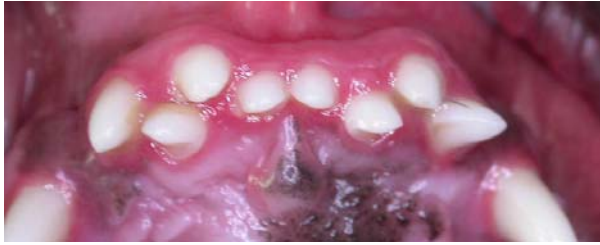
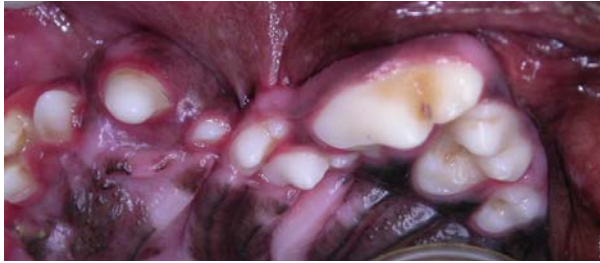
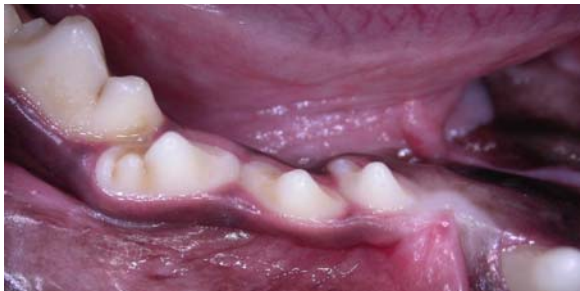
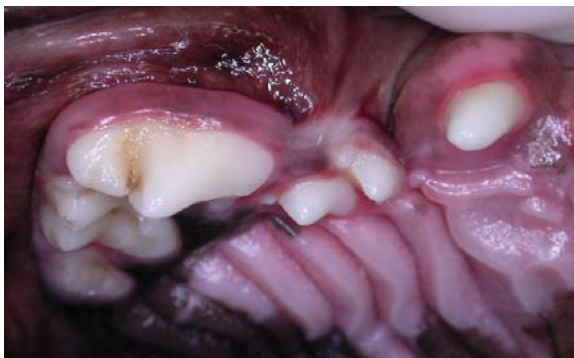
Then I dealt with other 'micro-dog' issues (see [microdogs.pdf](#)) such as extracting some supernumerary maxillary incisors and extracting several other teeth to alleviate the serious

crowding and rotations (see the pre-op photos) that would have pre-disposed to uncontrollable periodontal disease.

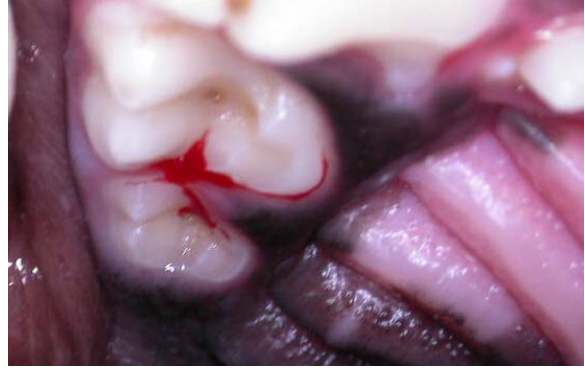
I also removed the right maxillary 2nd molar because the discolouration of the crown indicated that the pulp in this tooth was dead ([endo_dx.pdf](#)).
